NBSIR 78-1421

Fire Hazard Evaluation of BART Vehicles

March 1978

Final Report

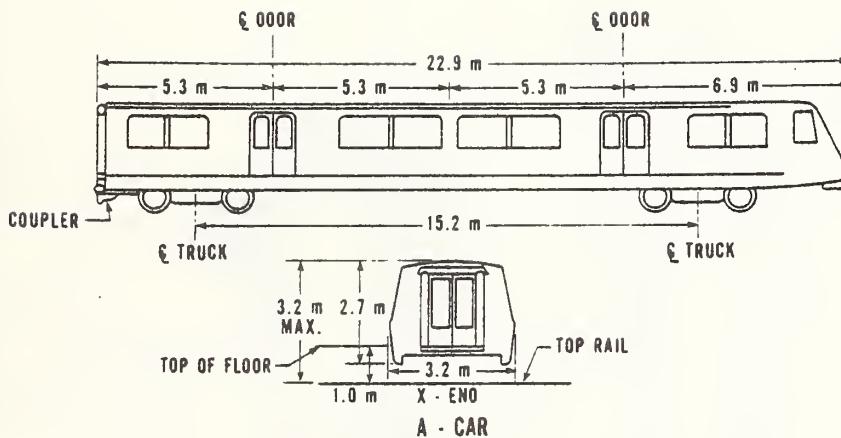
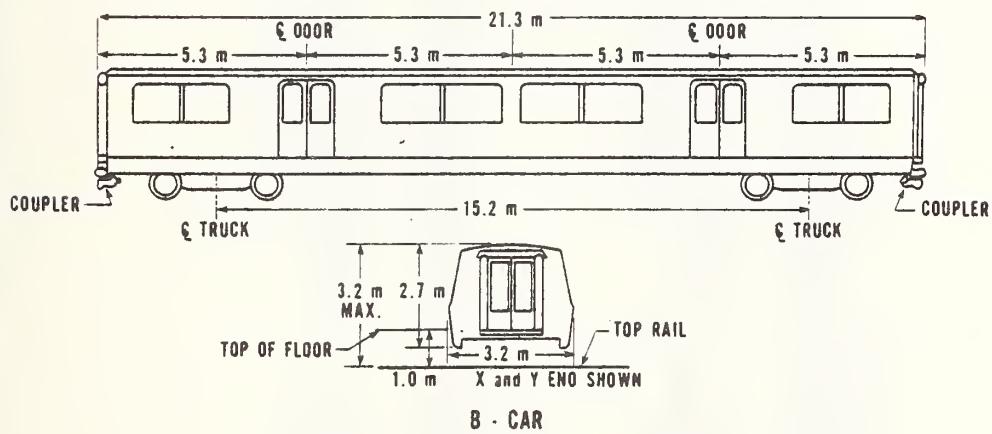
Figure 1. Exterior views of A-car and B-car configurations

BART vehicles come in two configurations, an A-car and a B-car (see figure 1) [1]¹. Except for the attendant's cab, which is mounted on the front of an A-car, both configurations are identical. An operational train is made by coupling up to eight B-cars between two A-cars. Since A-cars contain all train controls, the smallest train that can operate on the BART system is two A-cars coupled back-to-back.

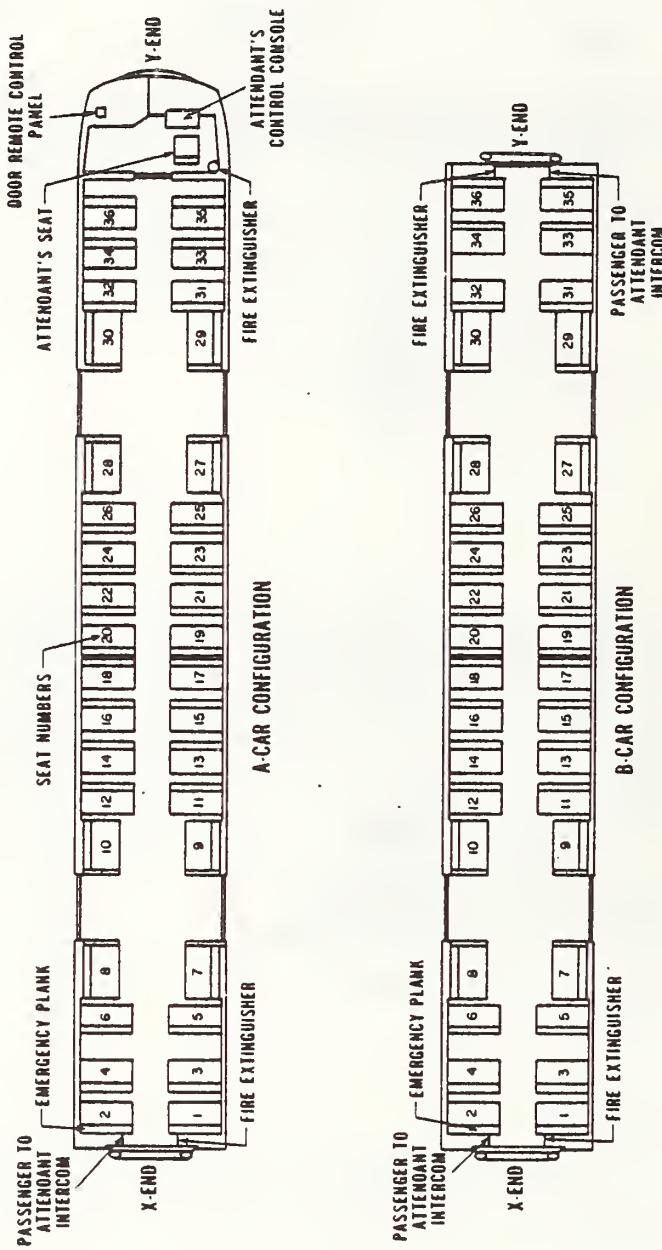
Figure 2. Seat placements in A-car and B-car configurations

Figure 2 illustrates the seat placement in the A-car and B-car configurations [2]. Each configuration provides sufficient seating for 72 passengers and a maximum "crush load" of an additional 216 standing patrons. There are eight longitudinal seats located behind modesty screens adjacent to each door. The remaining 28 seats are divided into three sections separated by the side entrance doors.

No active fire detection and suppression system exists on the BART system. Fire suppression takes two forms. For interior car fires, one fire extinguisher is located at each end of every car. In A-cars, one fire extinguisher is behind the attendant's seat, while the other is in a compartment behind seat number 1 (figure 2). In the B-car, the fire extinguishers are behind seats 1 and 36 (figure 2).

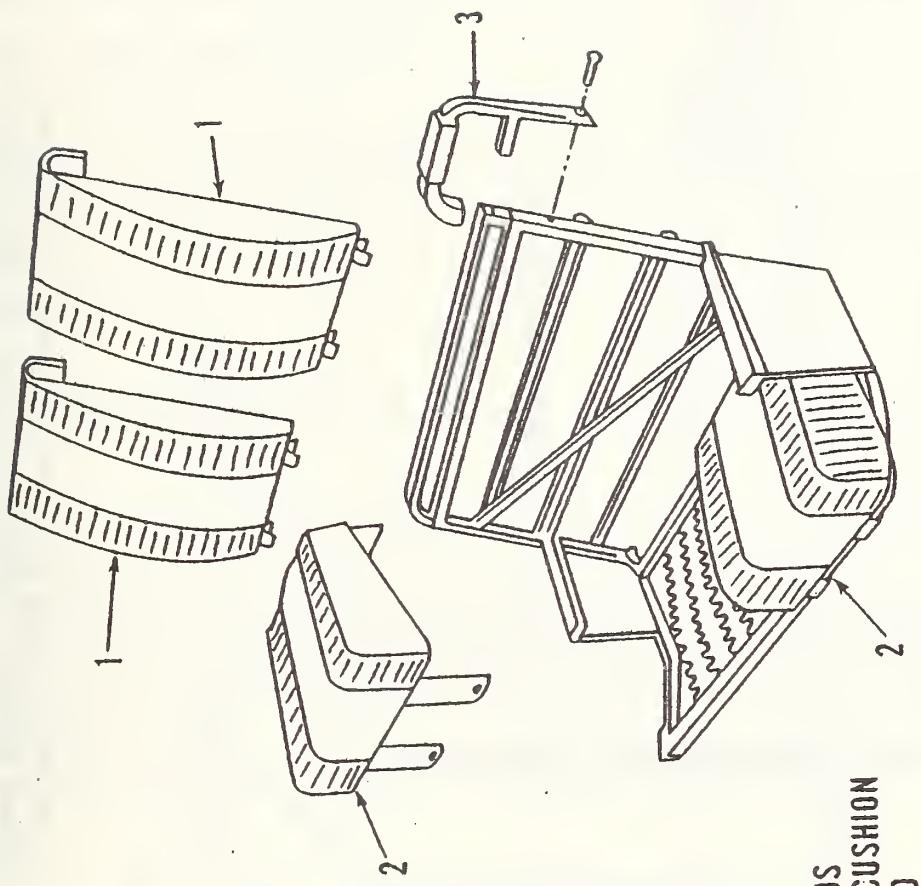
Figure 3. Seat assembly - cushions and frame

Each seat assembly consists of a molded urethane foam bottom and back encased in an upholstery fabric. The fabric is a combination vinyl/nylon assembly (figure 3) [1]. The outer edges of both bottom and back cushions are vinyl with the center section made of a nylon fabric. The seat cushions snap into the seat frame which, in turn, is attached to the sidewall.

Based on the scenarios postulated in section 6.1, initial fire growth from an interior fire source can be inhibited by improving the fire resistance of the seat assemblies. As currently designed, the seat cushions represent the largest contribution to the hazard level of the vehicle. There are several options available for upgrading the seat cushions. If we set aside, for the moment, the added problem of vandalism, the replacement of the nylon fabric in the upholstery design with a more fire resistant material would go a long way towards lowering the hazard from small incidental fires (i.e., a trash bag). An example of such a replacement is the use of a complete vinyl covering over the urethane cushions. If, however, one is concerned with vandalism, which may be the case in any subway system, or is concerned with larger ignition sources (i.e., newspaper), serious consideration must be given to replacing the existing cushions. It has been found that a fire-retarded neoprene cushion upholstered with a vinyl fabric is quite resistant to fire growth from larger ignition sources [9]. As a seat assembly, it has the added advantage of retaining fire retardant properties when the cover fabric is penetrated.

1. BART upgrade the flame resistance of the seat assemblies, e.g., by introducing all vinyl upholstery. In order to further increase evacuation time, serious consideration should be given to incorporating neoprene cushions with the vinyl upholstery.
2. BART investigate the technological and economic feasibilities of using an intumescent coating on the wall and ceiling liner.
3. BART develop a means for hardening the floor assembly against sub-car fire penetration at least in those areas most vulnerable to fire exposure.
4. BART, after additional study of detector types and locations, install a fire detection system to indicate the presence of a fire on board a train.
5. BART, in the interim, provide walk-through inspection after passing the terminal stations and/or prior to entering storage facilities.

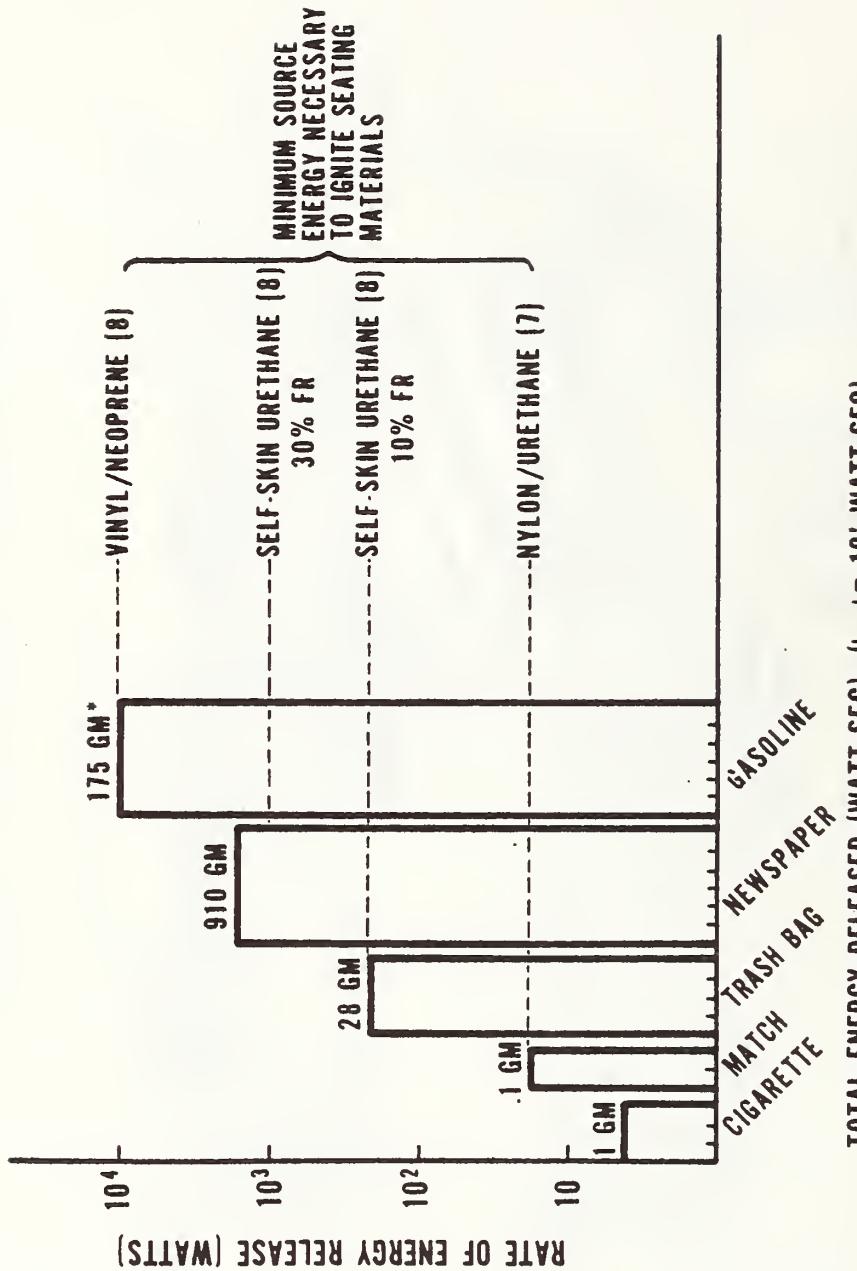
Figure 4. Comparison of ignition source characteristics and minimum ignition energies for various seat assemblies

So far, we have postulated fire growth patterns assuming an ignition, but have not considered the characteristics of the ignition source and the minimum energy necessary to cause ignition. Probable ignition sources range from smoldering cigarettes to flammable liquids. They differ only in the rate of energy release and the total energy released. The total energy in turn depends on the mass of combustible material in the ignition source. Figure 4 shows the relationship of energy release rate for various ignition sources to the total heat released for a given mass of material [7]. Based on previous experimental work [8,9], ignition levels for various seating materials are indicated. These minimum values were arrived at empirically in a series of experiments conducted on subway and bus seat assemblies currently in use. Strictly speaking, these results pertain to the physical constraints present and the materials employed at the time of these tests. Nevertheless, it can be inferred that a significant improvement in ignition resistance can be realized by changes in the materials used in constructing the seat assemblies.
